NaturalPave Case Study

Stabilization of Event Center Roads

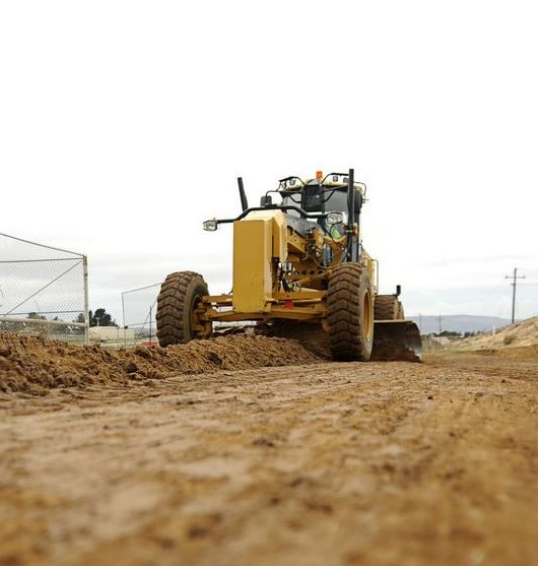
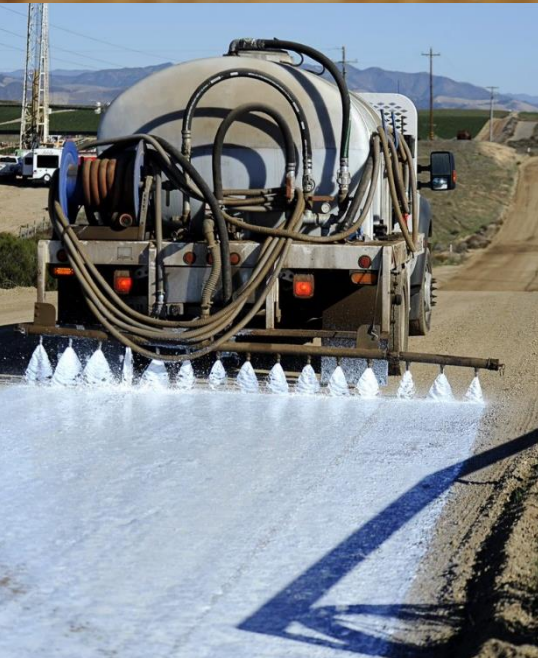
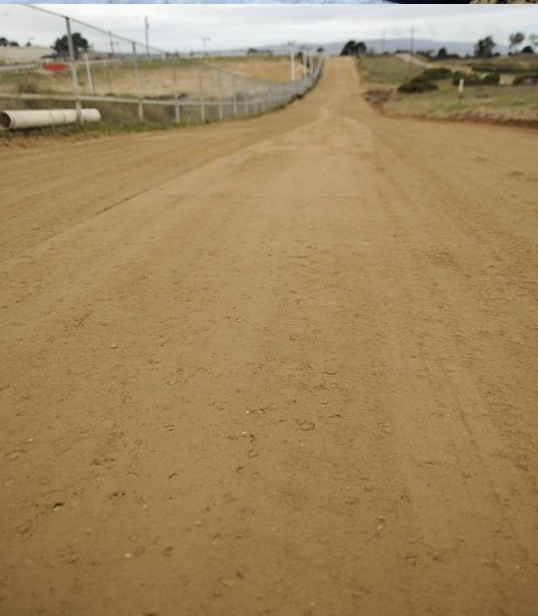
NaturalPave Installation

The following steps were taken to install the NaturalPave Stabilization system at the Santa Maria Event Center:

1. Scarify and loosen the existing surface".
2. Apply and incorporate the NaturalPave Base Stabilization System using a computerized spray truck and a tractor-mounted reclaimer.
3. Shape the treated road surface with the proper crown and profile.
4. Compact the treated road surface.
5. Apply a seal coat to prevent dust and surface erosion.

The stabilized road was allowed to cure for several days without traffic.

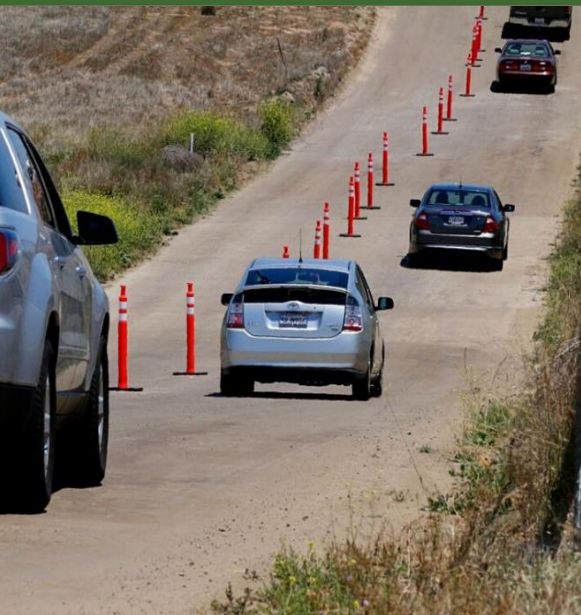
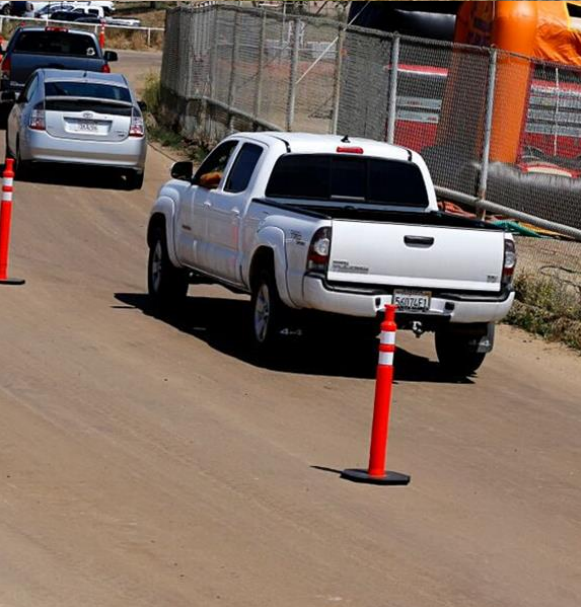
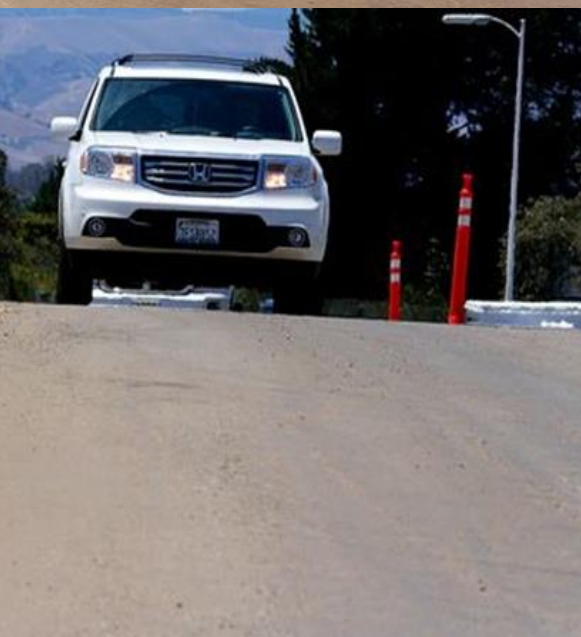
Geotechnical Evaluation

Nine years after the original installation, Midwest returned to the event center to perform Dynamic Cone Penetrometer (DCP) testing on the stabilized roads. DCP testing is a widely accepted and recognized field test to determine the in-situ strength of soil layers. DCP readings were collected at 8 locations along the centerline of the road and converted to California Bearing Ratio (CBR) readings.

The field testing shows an average CBR of 57 on the stabilized road surfaces - indicating a significant improvement in the bearing strength of the marginal native soils which are estimated to have an untreated CBR value of 10-15.

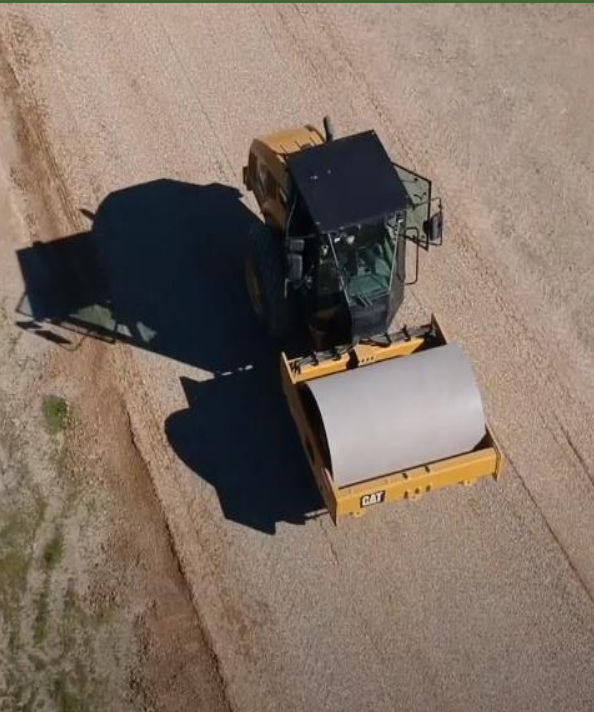
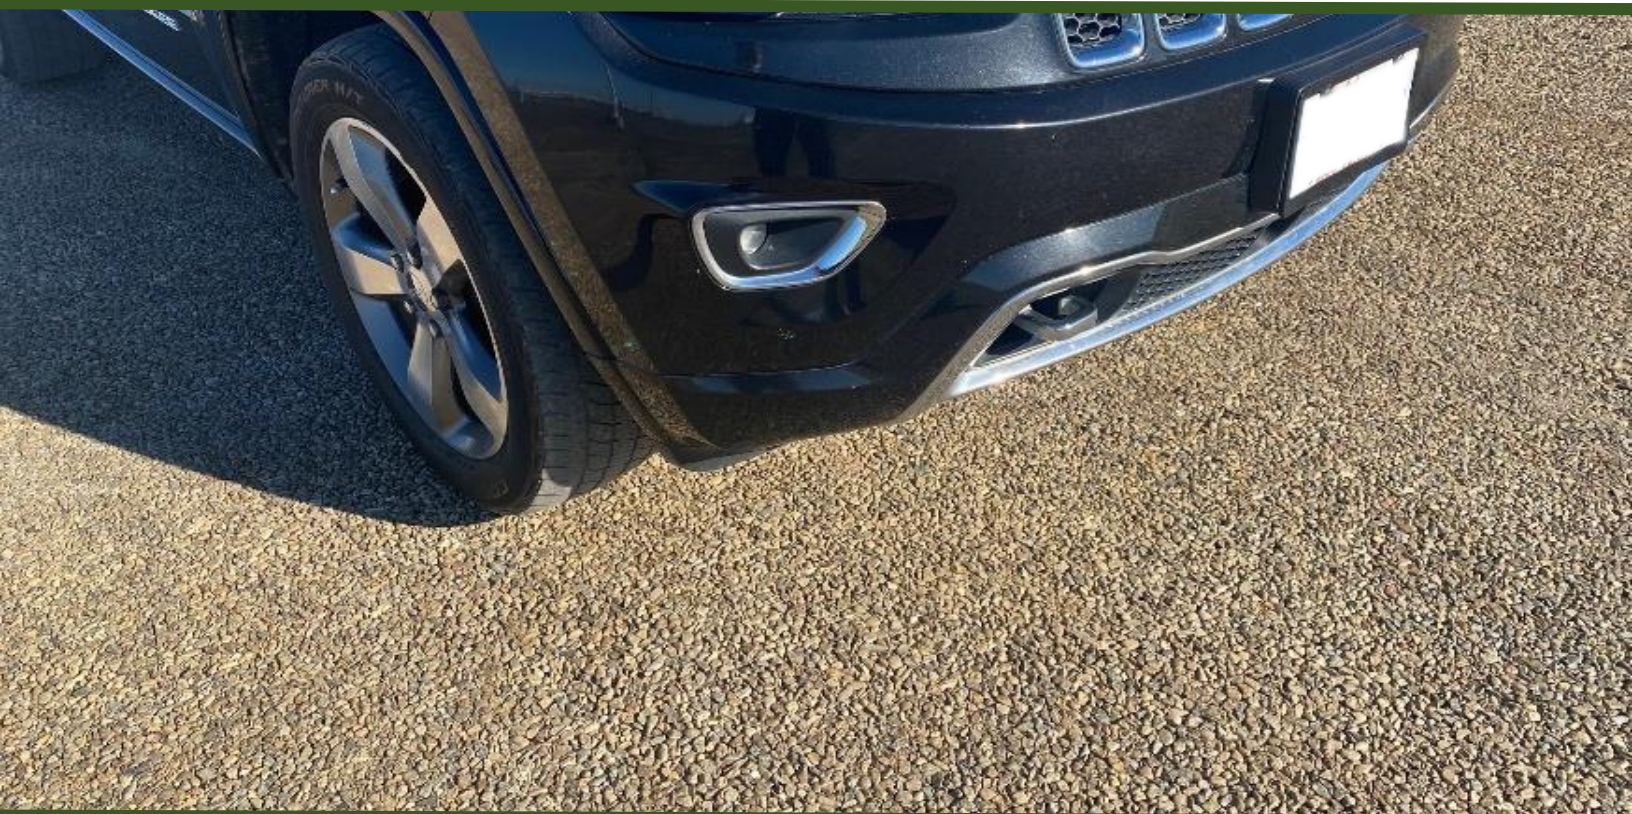
NaturalPave Surface

Due to the success of the original NaturalPave installation, nine years later SMEC requested Midwest return to stabilize a new section of road that runs behind their rodeo grandstands. Given the high visibility and pedestrian traffic in this part of the event center, they opted for a NaturalPave Surface to be installed on top of the NaturalPave stabilized road base.

The NaturalPave Surface is created by laying and embedding specifically selected stones into the surface prior to the stabilized layer curing. Following compaction of the stones, a seal coat is typically applied to further protect the surface against weather, abrasion, and erosion. NaturalPave Surfaces are durable, skid resistant surfaces that preserve the natural look of the surrounding area and help preserve the integrity of the NaturalPave stabilized road base. The surface stones can be chosen to meet the aesthetics of most natural environments.
